**Inch Property,
Kippenberger Avenue,
Rangiora**

Preliminary Geotechnical
Investigation Report

Westpark Rangiora Limited

Reference: 506685

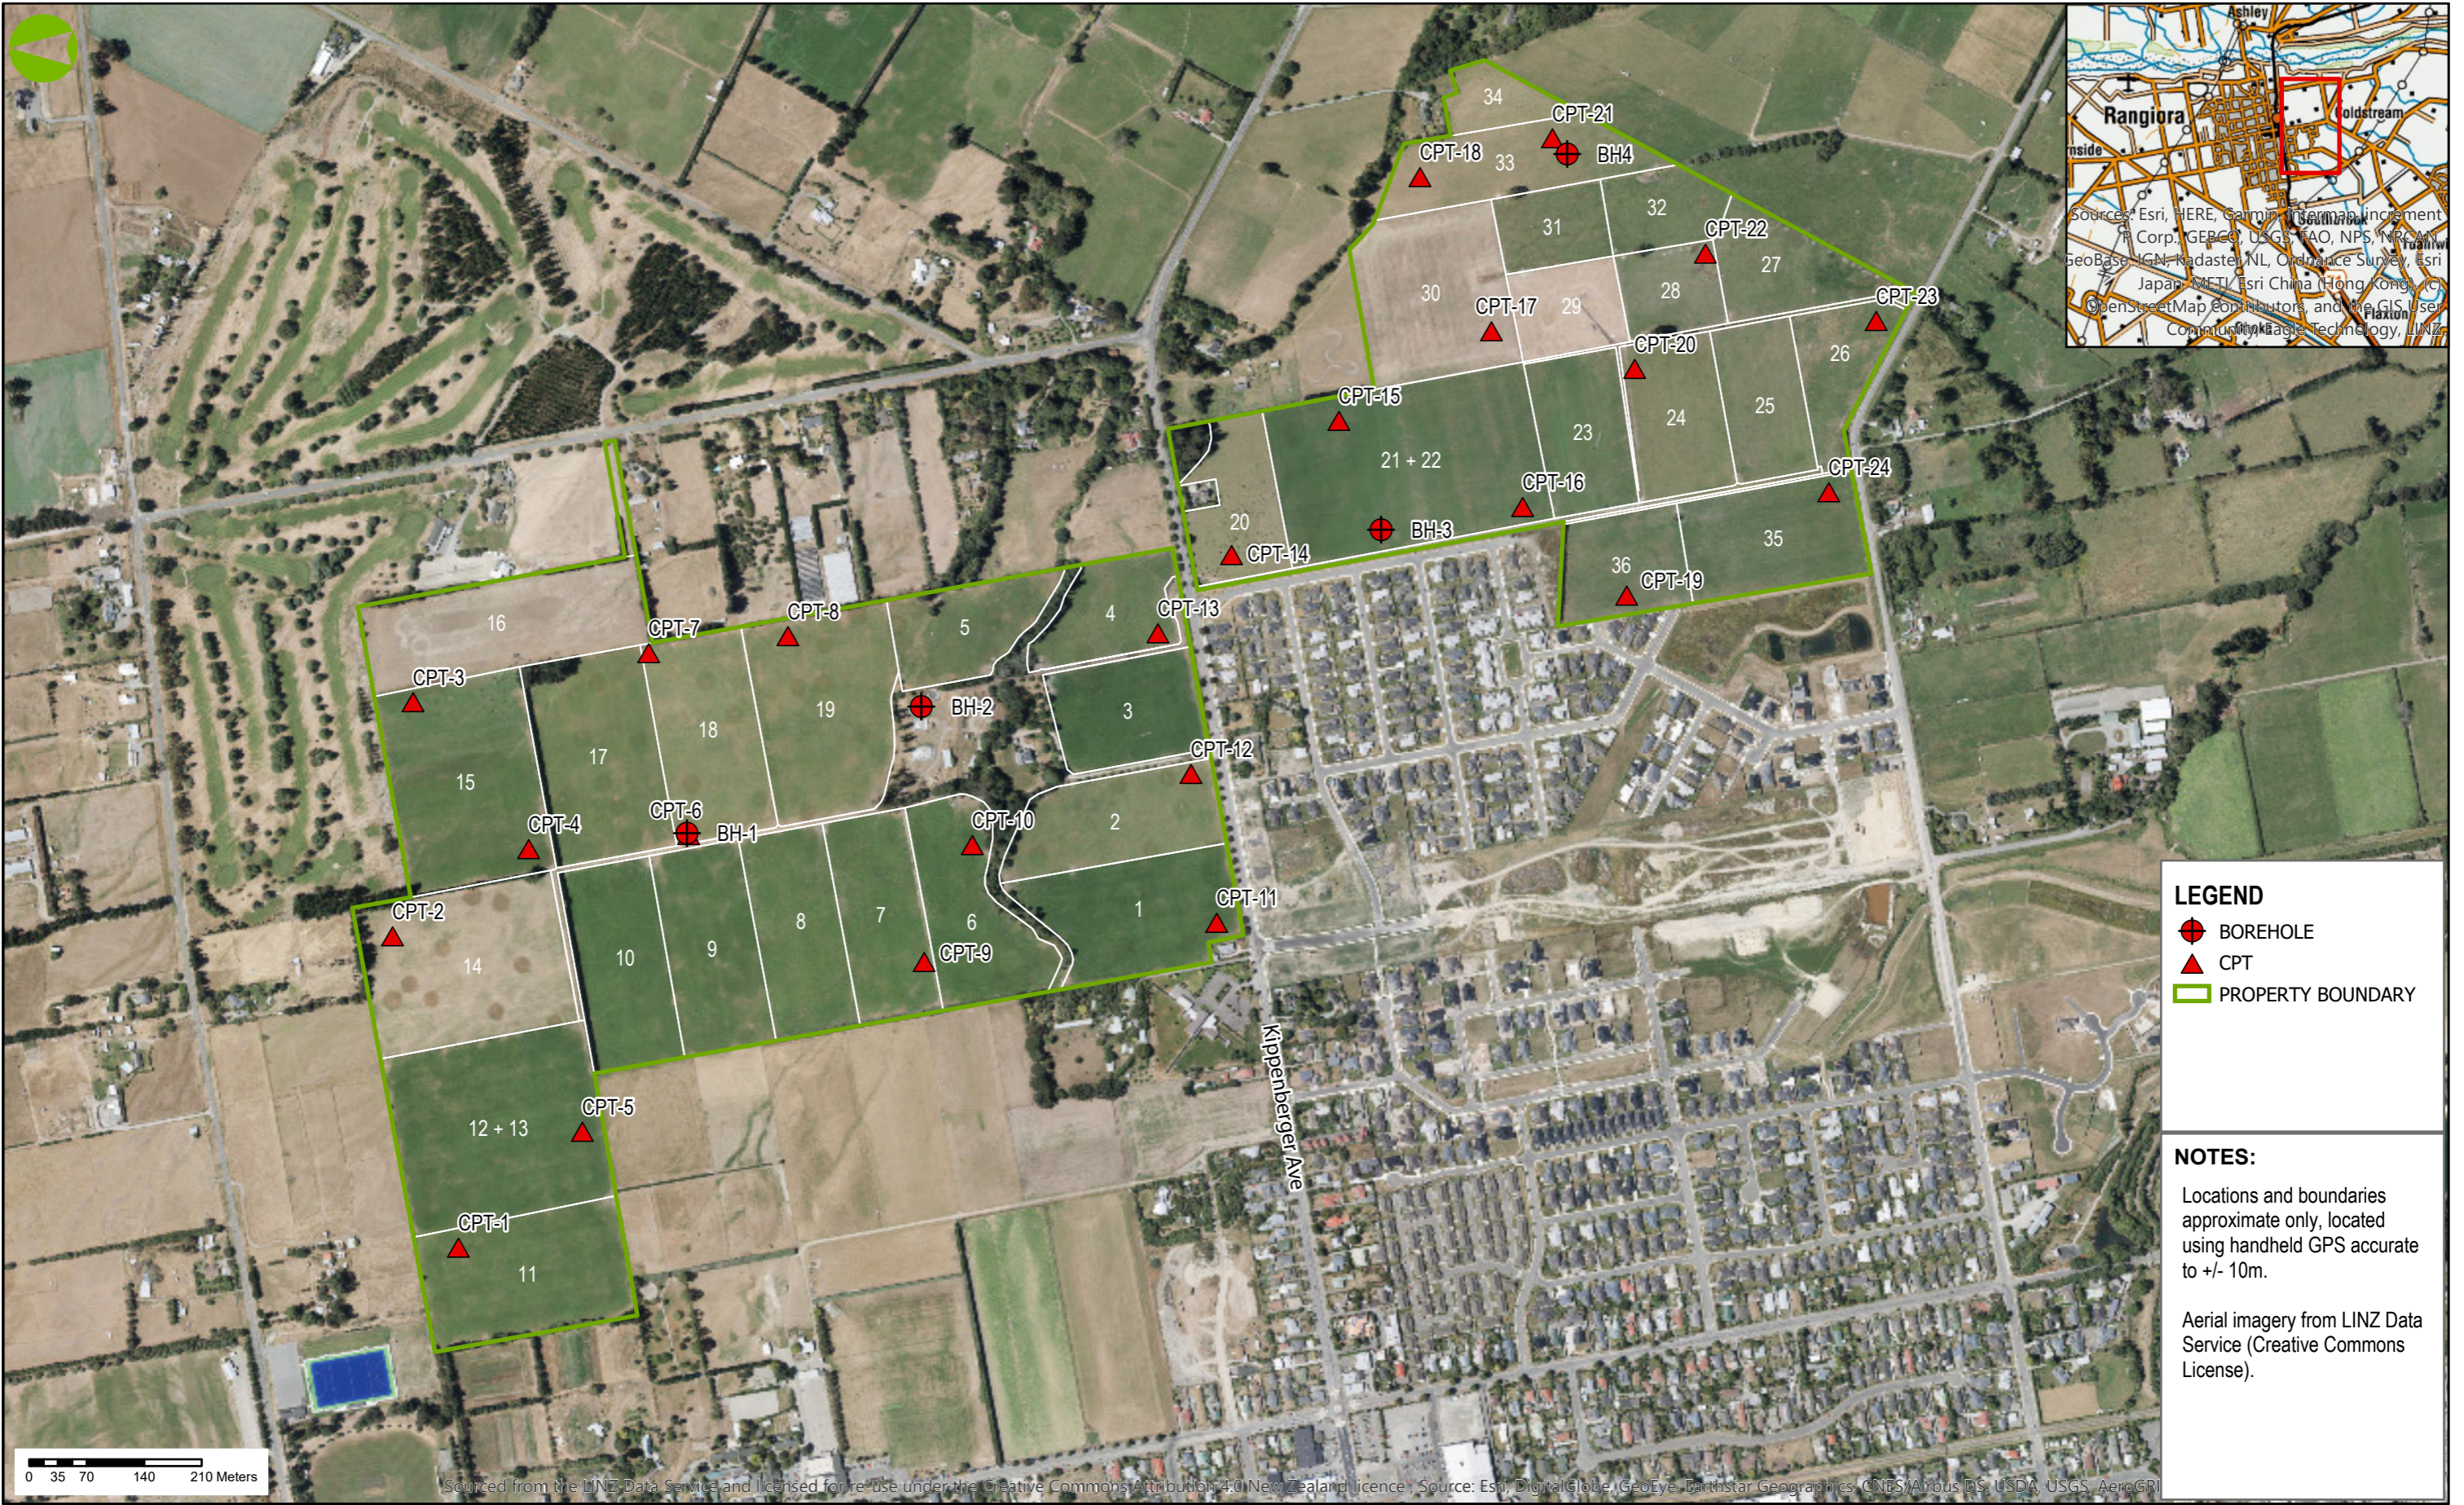
PROJECT	INCH LAND - KIPPENBERGER AVE SUBDIVISION DEVELOPMENT						
TITLE	PRELIMINARY SITE INVESTIGATION LOCATION PLAN						
DOCUMENT	PROJECT	ZONE	DISCIPLINE	ELEMENT	TYPE	SHEET	REVISION
	506685	0001	GG	0001	DRG	01	A

- BOREHOLE
- ▲ CPT
- PROPERTY BOUNDARY

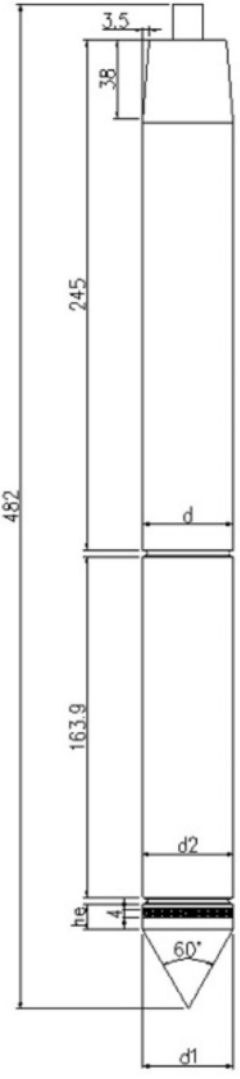
Dimensional specifications for all cone types are detailed below. All tolerances are routinely checked prior to testing and measurements taken are electronically recorded. All records are kept on file and available on request.

A.P. van den Berg Machinefabriek tel.: +31 (0)513-631355 info@apvandenbergh.com	DEVIATION of Straightness + MINIMUM Dimensions tip, friction jacket, cone adapter	Standards: EN ISO 22476-1 APB-standard		
Type of cone: <u>ALLOWABLE SIZE VARIATION</u> Diameter of tip: Diameter of centering ring CFP Diameter of friction jacket: Height dimension of tip edge: <u>PRODUCTION DIMENSIONS</u> Tip: Jacket (C-cone): Friction jacket (CF-cone): Tip for used cone: <u>MINIMUM DIMENSIONS</u> Minimum diameter jacket (C-cone): Minimum diameter friction jacket (CF-cone): Use "used cone"-tip when friction jacket diameter: Minimum diameter of cone adaptor: Maximum deviation of straightness:	Icone 10 cm ² $35,3 \leq d_1 \leq 36,0$ $35,3 \leq d_1 \leq 36,0$ $d_1 \leq d_2 < d_1 + 0,35$ $7 \leq h_e \leq 10$ $d_1 = 35,7^{+0,2}_0$ $d_2 = 35,7^{+0,2}_0$ $d_2 = 35,9^{+0,1}_0$ $d_1 = 35,5^{+0,1}_0$ $d_2 = 35,2$ (APB standard) $d_2 = 35,3$ $d_2 \leq 35,65$ $d = 35,3$ 1 mm on a length of 1000 mm (max. oscillation 1,0 mm.)	Icone 15 cm ² $43,2 \leq d_1 \leq 44,1$ $43,2 \leq d_1 \leq 44,1$ $d_1 \leq d_2 < d_1 + 0,43$ $9 \leq h_e \leq 12$ $d_1 = 43,8^{+0,2}_0$ $d_2 = 43,7^{+0,2}_0$ $d_2 = 44,0^{+0,1}_0$ $d_1 = 43,5^{+0,1}_0$ $d_2 = 43,0$ (APB standard) $d_2 = 43,2$ $d_2 \leq 43,7$ $d = 43,8$ 1 mm on a length of 1000 mm (max. oscillation: 2.0 mm)

Tip and Local Friction sensor displacement The different distances of the sensors are compensated depending on the cone types: • 10cm ² cones: 80mm • 15cm ² cones: 100mm
