25 November 2021

## Risk of Natural Hazards & Soil Contamination at 163 ~ 203 Johns Rd, Rangiora

Eliot Sinclair were engaged to undertake a desktop review of the geotechnical conditions, and to comment on any obvious risk of natural hazards for 163 Johns Road, Rangiora.

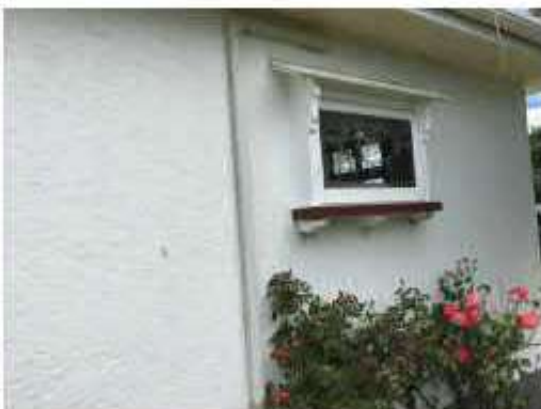
Figure 3: Plastered pre-1940s weather board dwelling.

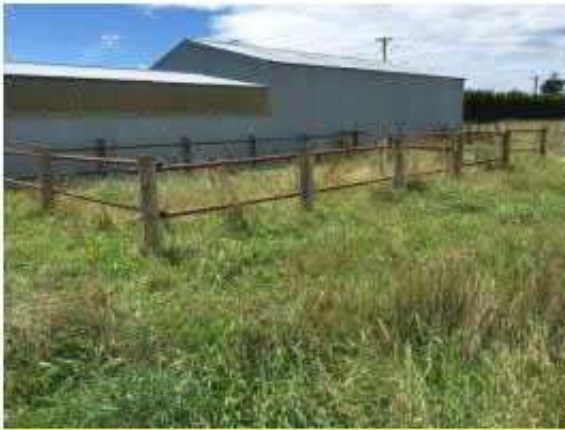
**Figure 5: Disused historical stockyard area with potential spray race (approx. 25m east of original dwelling)**

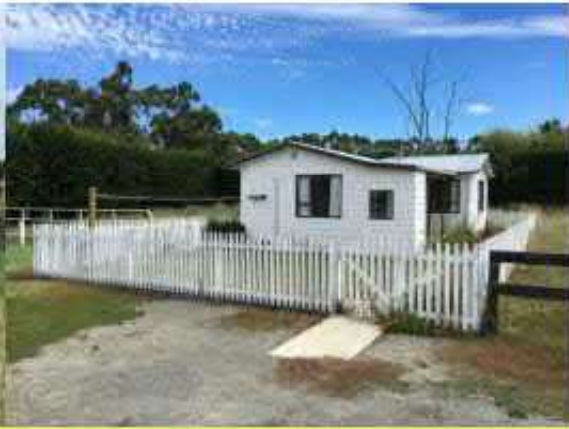
**Figure 8: More recent residential dwelling, established in the 1980s. The exterior cladding and internal plaster materials might contain asbestos fibres.**

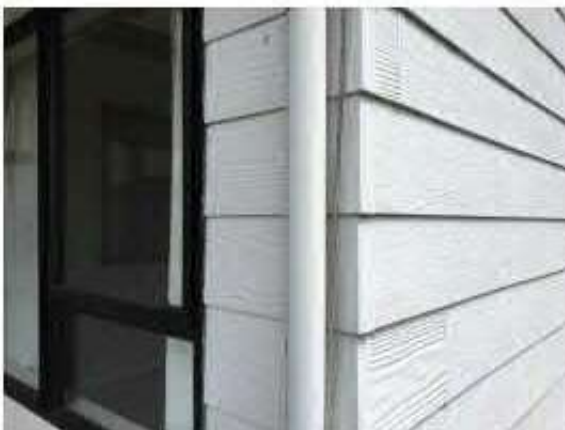
The exterior cladding of the more recent residential dwelling that was established in the 1980s might contain asbestos (Figure 9). Stippled plaster on the ceiling inside the dwelling might also contain asbestos fibres (Figure 10).

**Figure 9: Exterior cladding of the more recent residential dwelling (possibly containing asbestos).**

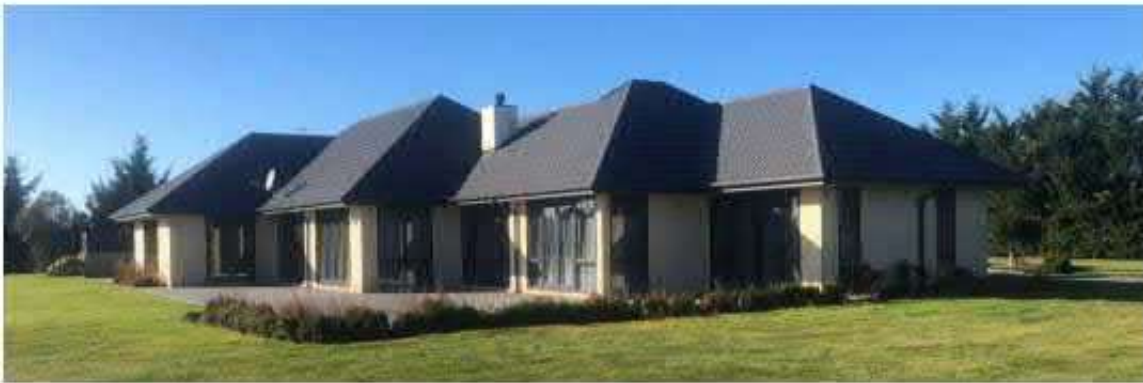
Photo 1. View of the residential dwelling at 199 Johns Road

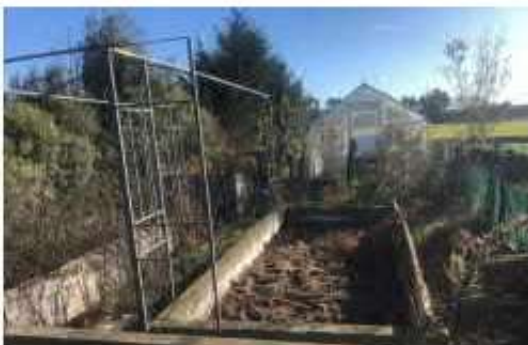
Photo 3. Raised gardens and disused domestic glasshouse
